Product Bulletin

Bulletin No.: 1302023

Subject: 3700 Salt Sensor & Cable

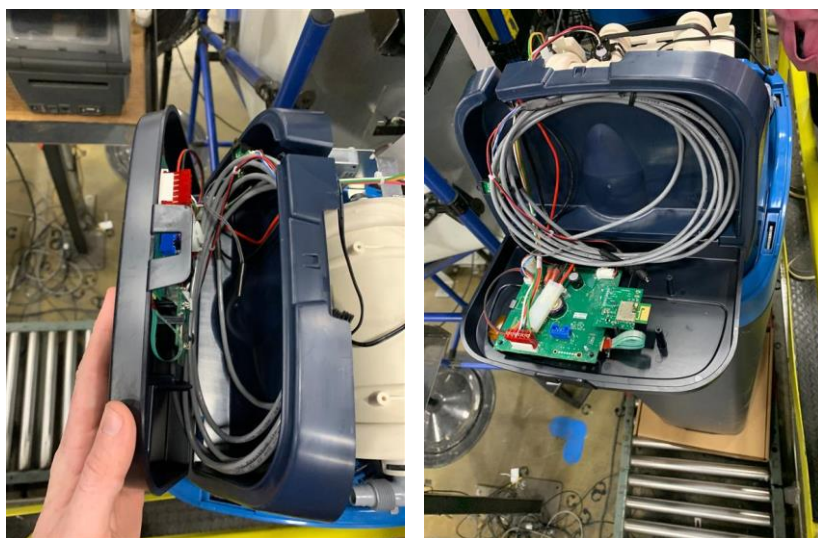
We have been made aware of a manufacturing process deviation impacting a small number of Next Gen 3700 water softeners in which the salt sensor and cables were being placed behind the control panel and not wrapped around the valve as they are normally shipped.

The salt sensor and cable can be found tucked behind the control panel and accessed by opening the control panel front cover (images included).

This manufacturing issue has been corrected and we have returned to the standard process.
